Manhole Inspection Summary

Manhole # S35EE_033MH

Location Address: **4 BIDDLE ST**

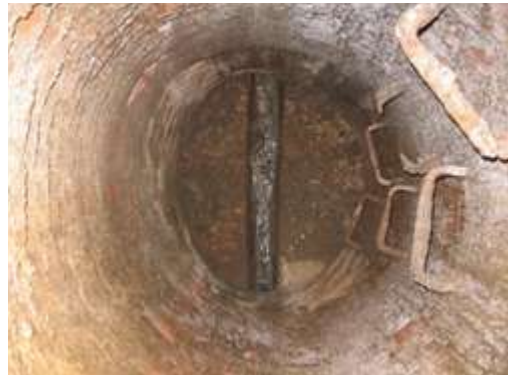
Top View

Steps Count: **6** Missing: **1** ☒ **Corroded**

Surcharge ☒ **Evidence Of Surcharge** Depth: **2** (ft.) ☐ Active Surcharge Present

Corroded and missing steps. Evidence of surcharge - Bench debris. Channel debris.

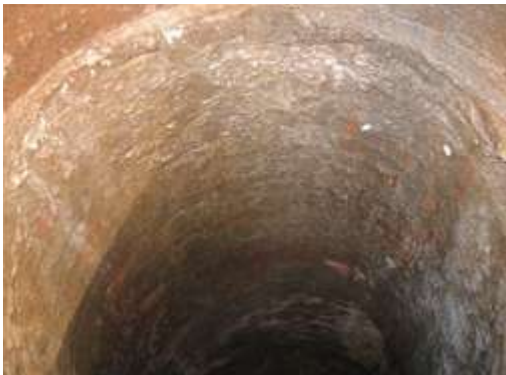
Defect

Frame Offset: **0** (in.) Condition: ☐ Sound ☐ Cracked ☒ **Leaks**

Condition: ☐ Sound ☐ Cracked ☐ Root Intrusion ☐ Loose Brick ☒ **Deteriorated**

Infiltration: ☐ None ☒ **Joint** ☐ Cracks ☒ **Mortar** ☐ Roots ☒ **Wall**

Frame leaks. Adjustment deterioration and infiltration. Corbel and Barrel infiltration.

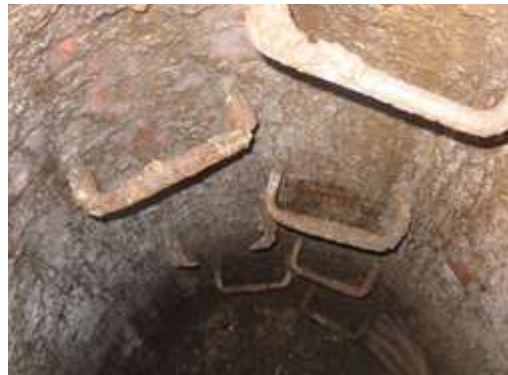
Defect

Corroded and missing steps.

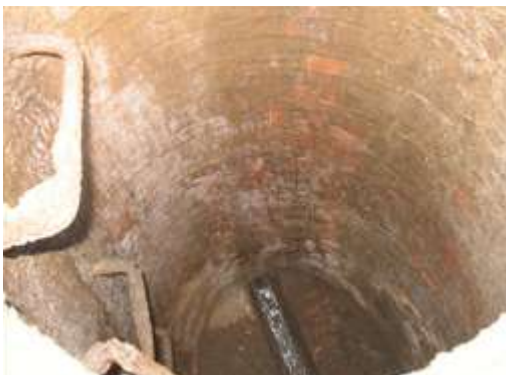
Defect

Frame leaks. Adjustment deterioration and infiltration. Corbel and Barrel infiltration - other side.
